Remaining Life Assessment of Kotabaru 2x7 MW Coal Fired Power Plant Circulating Water A252 Gr 2 Intake Pipe by Inspection Method

ABSTRACT: Kotabaru power plant is a power plant that was built in 2010 and currently the construction work is pending. The construction work stopped in 2014 and based on Kotabaru power plant construction final quantity report, Kotabaru construction work progress is 79,61% up to now. Kotabaru power plant uses open cooling system and takes seawater as cooling water resources. The seawater distribute through intake pipeline which use A252 grade 2 material 600 mm and 800 mm diameter pipeline with 3PL coating and rubber lining inside the pipe. The pipeline distribute the water in 3.184.739 kg/hr flow rate and 5 kg/cm² G pressure. These pipeline material was on site in 2013 and it was not constructed yet. In 2022 Kotabaru power plant is planned to continue the construction work progress. It was about 9 years of pipeline material on Kotabaru power plant site and these pipeline is exposed to the environment such as sunlight, temperature, oxygen, water, and contaminants and cause a primer failure, especially ultraviolet light (UV) from the sunlight is the main da

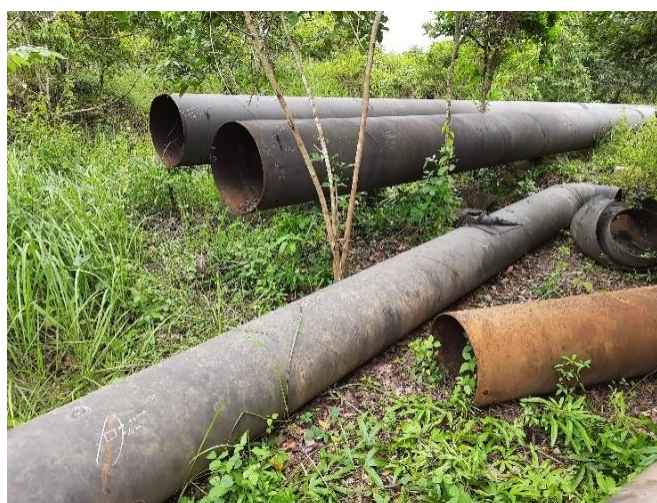
Those pipes, elbows, reducers, and spools will be constructed into pipeline system that distribute water for steam cooling system. The pipe length is about 798.86 meter length pipeline. The pipe line design is shown in Figure 1 below, and the condition of current pipes is shown in Figure 2 below. The pipes and another fitting accessories are steel pipes that coated by epoxy in outer pipe and these are coated by rubber lining inside. The design pipes, spools, reducers, and elbows are shown in the figure 3 below, the pipe uses steel pipe design A252 gr 2 material coated with epoxy outside, and rubber lining inside.

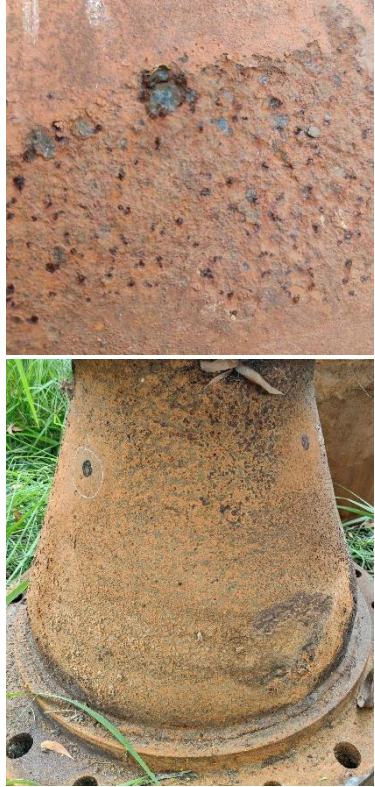
<p>Those defects are some types, such as cracking cause the decreasing flexibility of coating and increase the brittle of its characteristic. Also there are some rust staining, and undercutting caused of corroded substrate.</p>

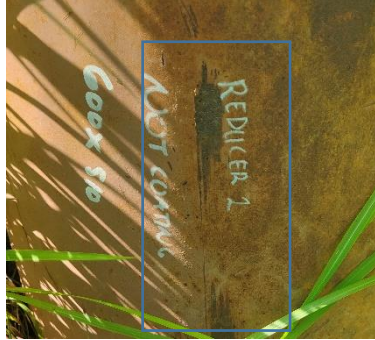
<p>Abrasive coat, this defect is removal of a portion of the surface. It caused by the surface contact with another object. This defect is found in some pipes and reducer. It can be exist caused by the handling material.</p>

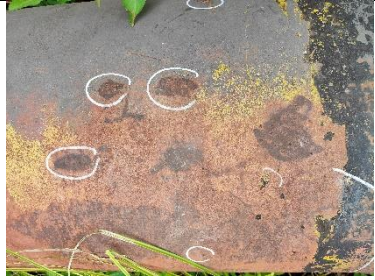
<p>Bloom (Blush), this coating happened by the film exposed to temperature and weather. It happen in some high humidity area, for example under a tree, or in an area that is flooded with rainwater.</p>

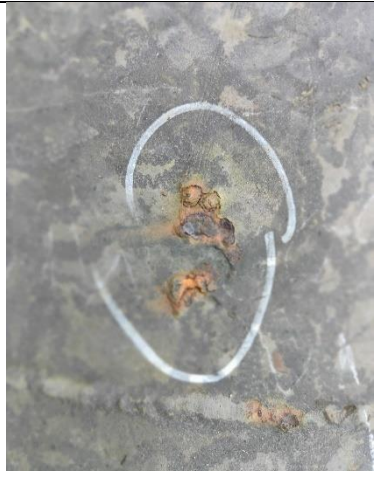
<p>Rust Staining, this defect caused by the exposure of ferrous oxide to the steel. It is also common defects that happen in the pipeline surface.</p>

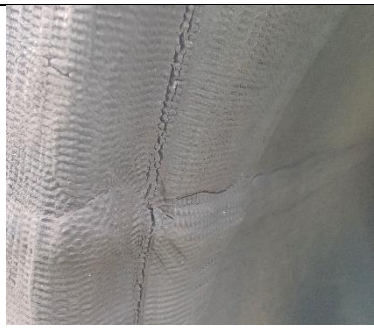
<p>Cracking of rubber line, the rubber exposes the weather, temperature and water of rain. The flexibility decreasing and make the rubber becomes brittle.</p>

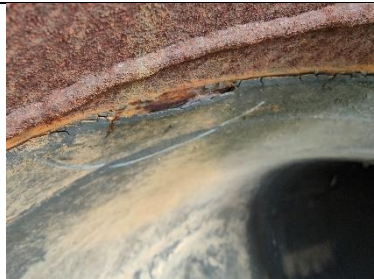
<p>Pelling defects cause of the adhesive of rubber and steel decreasing and also expose to the weather make the rubber becomes brittle.</p>

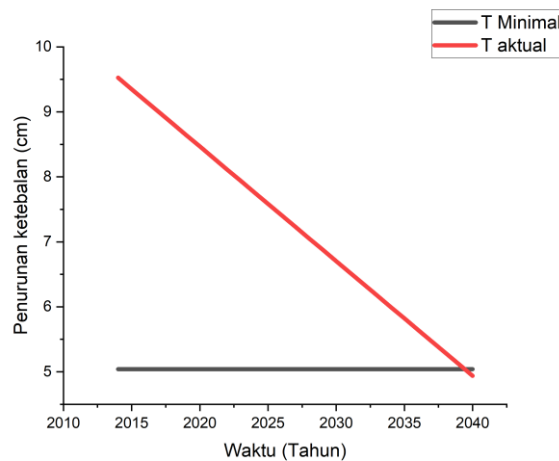
Figure 9. remaining lifetime pipe number 13

For the pipe number 13 thickness would be 4,9 mm in 2040 and still 16 years left for operation.
