Assessment of the Management of Museum Storage Units at The National Museum of Tanzania: Reality and Challenges

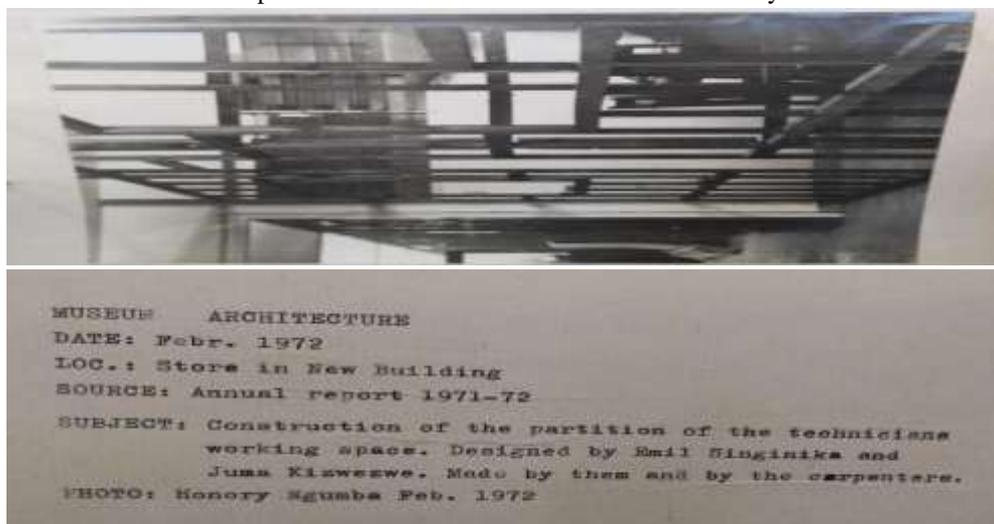
At the Museum and House of Culture, collection storage management draws its roots from colonial period in 1940 when the King Gorge V Building was officially opened by the British Government. Objects were being stored in unprofessional manner. Facilities fixtures and fittings were very poor and of course there were no professional curators and conservators during that era. The study reports different versions of storage facilities that were procured by NMT to carter the requirement of each period. To mention few, the National Museum of Tanzania has been preserving collections on open shelving units, in closed door cabinets, in flat storage (such as drawers), and in acid-free boxes and bags of various sizes and shapes. Most of the storage units at NMT had poor ventilation system and AC were not available. Open shelving units allowed collections to be exposed to excessive heat, dust and light all of which are dangerous for the lifespan of objects. During the study, it was also observed that one of the storage racks which was used to preserve ethnographic objects in the King Gorge Building, was found to be very crude compared to the current ones. Corrections were not safer because of their poor accessibility and the wooden materials are not suitable for ethnographic objects because, untreated wooden cabinets are more susceptible to insect infestations which in turn destroy collections.

Figure 1: A photo of a storage rack that was used to preserve museum collections in King Gorge V building since colonial period up to 1960s and 1970s.

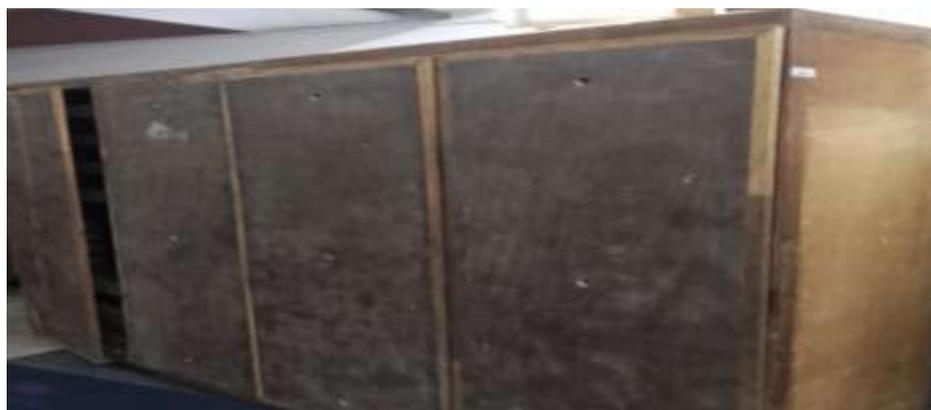
Figure 2: An old cabinet that was infested and worn out at the Museum and House of culture. It was used to keep archaeological collections until 1990s.

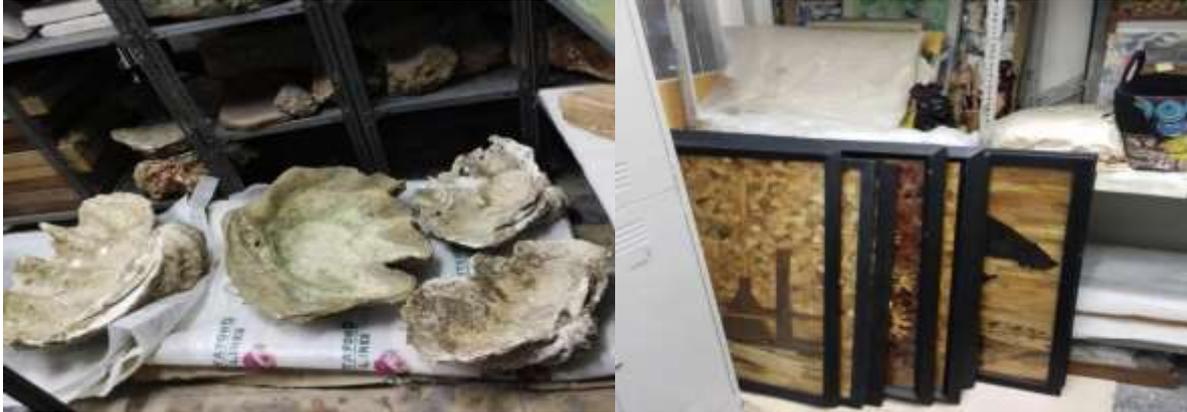
The study indicates that, generally there is an improvement of storage facilities at the National Museum of Tanzania. For instance, in the sections of Biology, Palaeontology, History and Archaeology a lot of improvement to re-organize storage system have been done especially after getting the COVID -19 relieve funds that the government of Tanzania has had distributed to her Ministries, Departments and Agencies. Experience shows that since 2010 to date several collection storages at NMT have been refurbished and new facilities procured. However, due to inadequate fund those facilities such as furniture, fixtures and fitting are not enough to accommodate all collections available per each department or section. In almost all storage surveyed in due of this study, none of them had all their collections in shelves, racks and in cabinets. Some of the objects are placed directly on the floor or on trays contrary to requirement of the professional codes of museum ethics.

Figure 4: Paleontological and Artistic collections stored on the surface due to lack of enough cabinets/shelves/racks

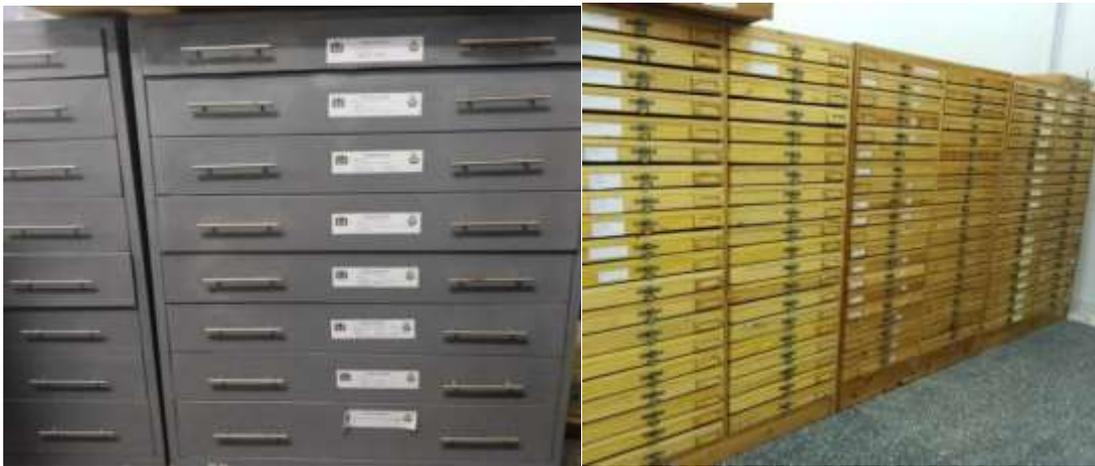
Figure No 5. Some of the modern metal racks in the History and Biology sections at NMT

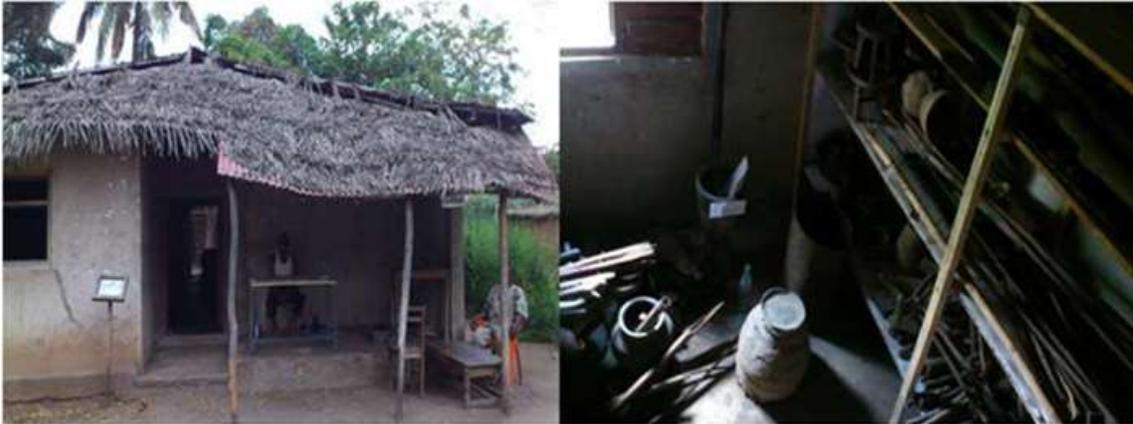
The VM storage was too local in such a way that it could not protect the collections preserved in it. The roof was palm leaves hatched of which allowed water leakage during rain seasons. Its walls, which were made of tree logs and soil plastered, had small halls which allowed insects to penetrate and affect ethnographic objects. Further, because of the nature of the storage, relative humidity and temperature was impossible to control as no AC could be fixed in such a traditionally built house.

Figure 3: An old storage of ethnographic objects at the Village Museum

Based on the challenges associated with the Village Museum storage unit, the National Museum of Tanzania earmarked a room in the main building and converted it into a storage. Modern facilities including steel mobile shelves, racks and cabinets were purchased for the protection of collections. Similarly, ACs were fixed to ensure temperature was put under control all the time for the longevity of museum objects.

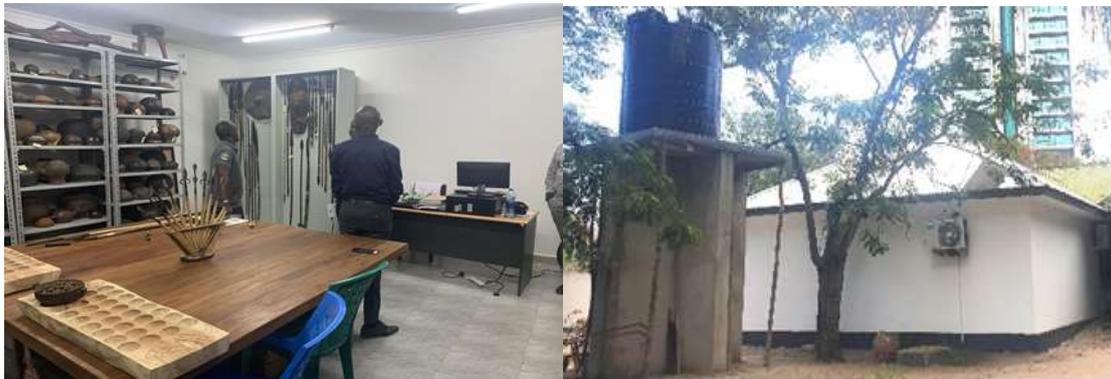
Figure 4: A re-organized storage of ethnographic objects at the Village Museum

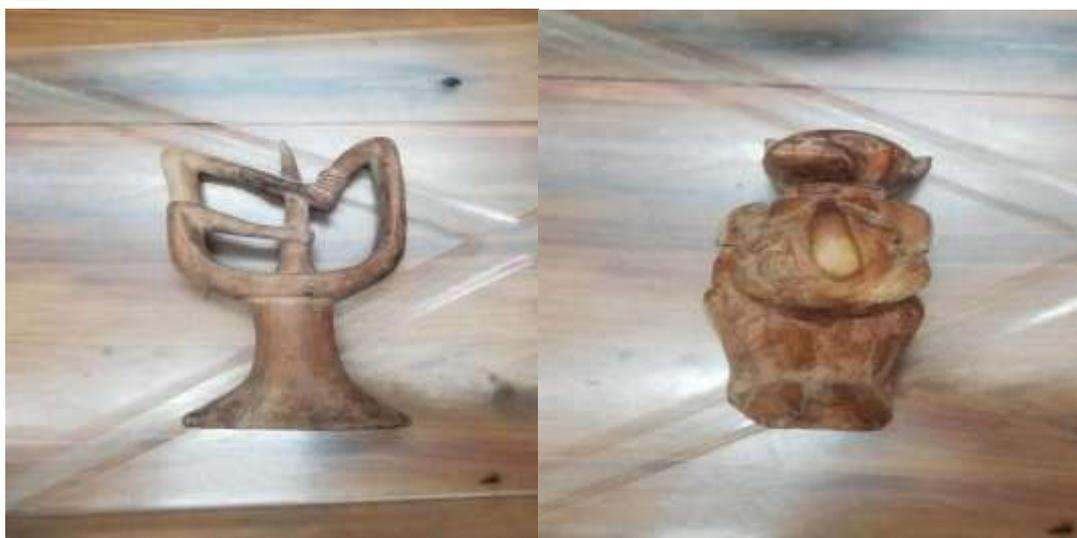
The study assessed concerning mold growth in NMT storage units. Availability of mold leads to the production of VOC's (Volatile Organic Compounds) and various toxins, which can provoke allergic reactions to museum staff, researchers and the public. According to Christensen, J. et al. (2016), Mold needs humid conditions below 65 -700% to grow. This survey revealed that, NMT is trying to observe these standards but following the limited financial resources it has, mold grows in various storage due to infrastructural leakages. The Palaeontology storage at MHoC has a serious leakage of rainy water that gets through structural cracks. Further, the storage experiences periods of very humid climate beyond 70% RH putting a high risk of severe mold attack. Figure 7 below, demonstrates some of the affected artifacts at one of the storages at MHoC.

Figure7: Art objects that were affected by mould at Museum and House of Culture: Before treatment

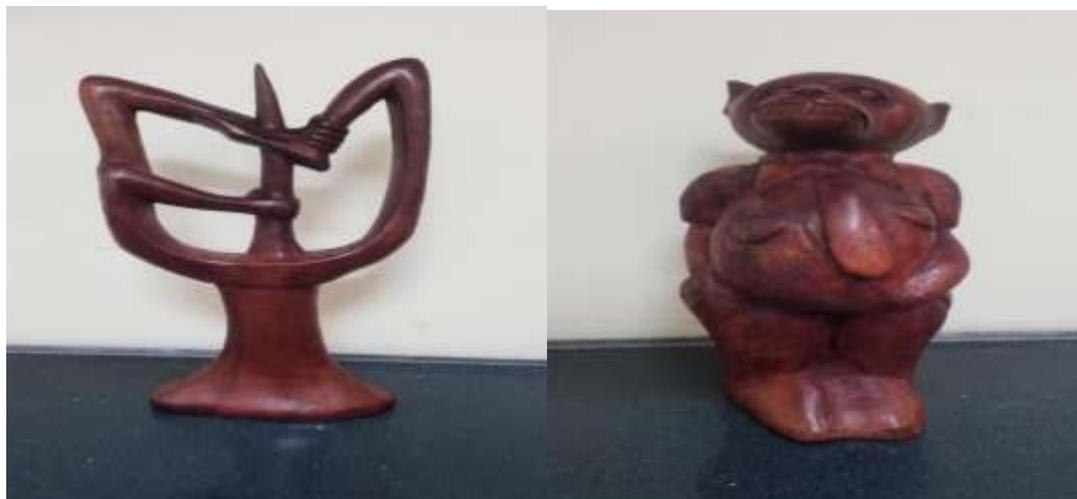
Figure No. 8 Art objects that were affected by mould at Museum and House of Culture: After treatment
