Remaining Life Assessment of Kotabaru 2x7 MW Coal Fired Power Plant Circulating Water A252 Gr 2 Intake Pipe by Inspection Method

ABSTRACT: Kotabaru power plant is a power plant that was built in 2010 and currently the construction work is pending. The construction work stopped in 2014 and based on Kotabaru power plant construction final quantity report, Kotabaru construction work progress is 79,61% up to now. Kotabaru power plant uses open cooling system and takes seawater as cooling water resources. The seawater distribute through intake pipeline which use A252 grade 2 material 600 mm and 800 mm diameter pipeline with 3PL coating and rubber lining inside the pipe. The pipeline distribute the water in 3.184.739 kg/hr flow rate and 5 kg/cm² G pressure. These pipeline material was on site in 2013 and it was not constructed yet. In 2022 Kotabaru power plant is planned to continue the construction work progress. It was about 9 years of pipeline material on Kotabaru power plant site and these pipeline is exposed to the environment such as sunlight, temperature, oxygen, water, and contaminants and cause a primer failure, especially ultraviolet light (UV) from the sunlight is the main da

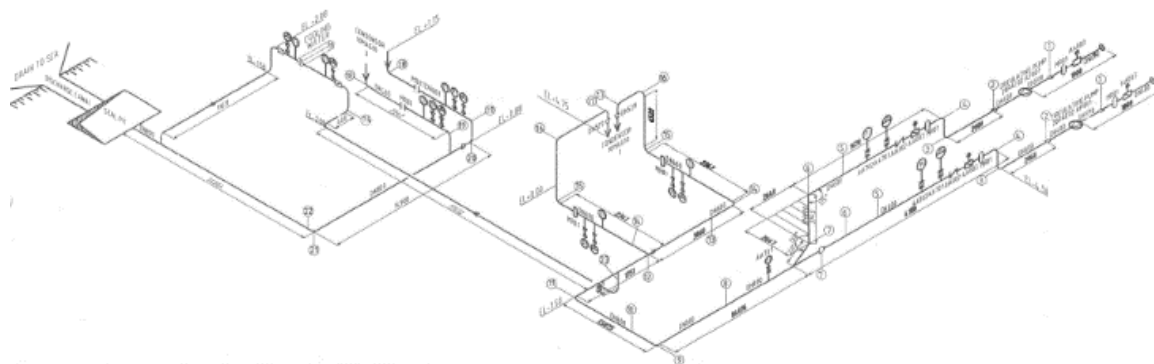
Those pipes, elbows, reducers, and spools will be constructed into pipeline system that distribute water for steam cooling system. The pipe length is about 798.86 meter length pipeline. The pipe line design is shown in Figure 1 below, and the condition of current pipes is shown in Figure 2 below. The pipes and another fitting accessories are steel pipes that coated by epoxy in outer pipe and these are coated by rubber lining inside. The design pipes, spools, reducers, and elbows are shown in the figure 3 below, the pipe uses steel pipe design A252 gr 2 material coated with epoxy outside, and rubber lining inside.

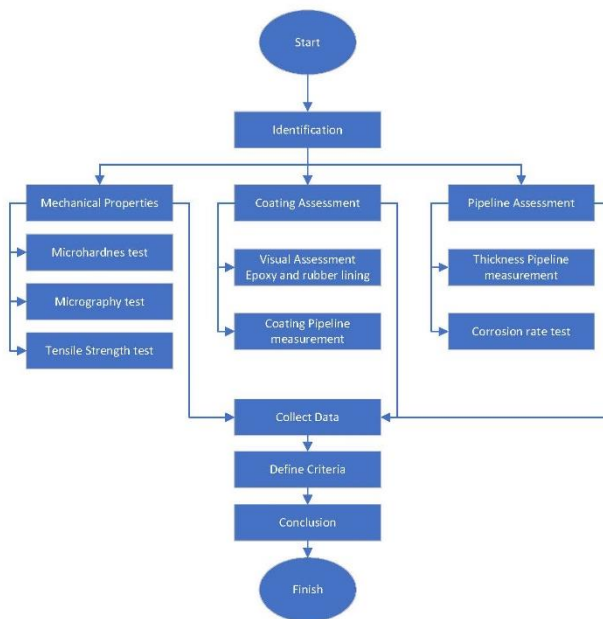
Figure 4

The process is divided into 3 parts that shown in Figure 4, the first one is determining about material properties and the type of steel pipe. To confirm about material properties, can be determined by microhardness test, micrography test, and tensile strength test. Assessment work is carried out to determine the condition of the outer pipeline and the inner pipeline. It is because the outer pipeline is coated by epoxy and the inner pipeline is coated by rubber lining.

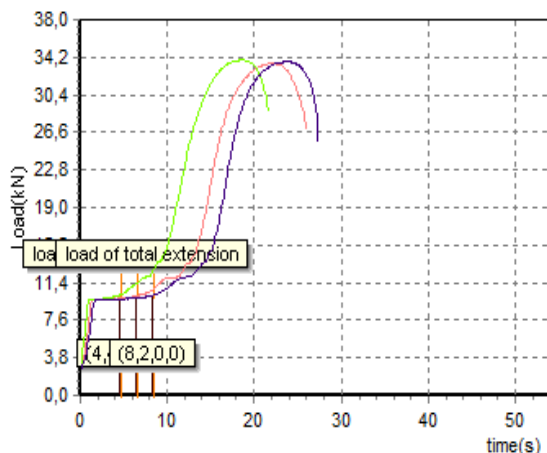
Figure 5

Microhardness test is done by *Rockwell Hardness Test* according to ASTM E10 standard. And then micrography test to define the microstructure steel characteristic and the magnification about 50x, 100x, 200x, 500x. Another test is strength test to determine the strength of material it self by using Universal Tensile Machine and ASTM E8 Standard. The tensile strength test can be defined the yield strength and ultimate tensile strength. The graphic of tensile test result is shown below on Figure 5.

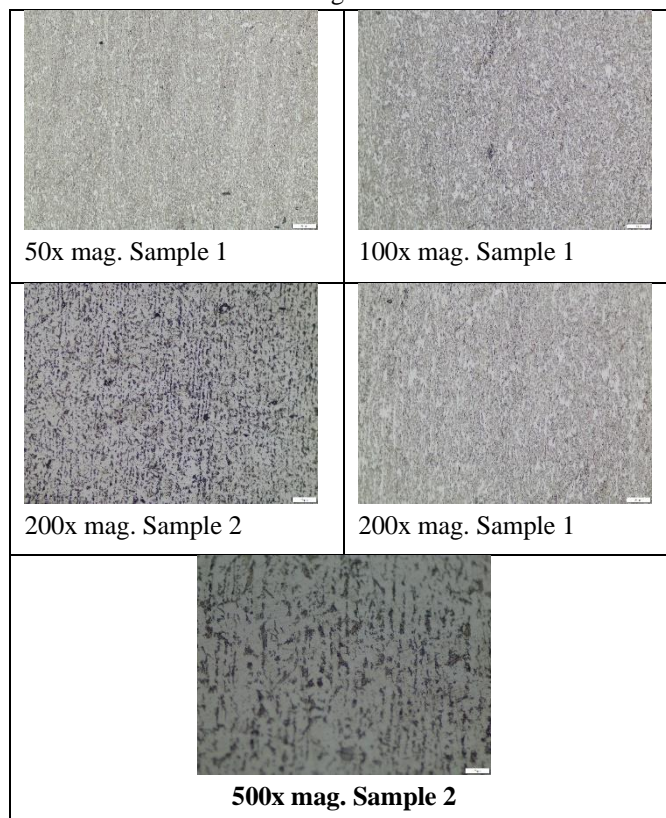
Figure 7

The sample of hardness test is taken form 3 part, and that is for determining the similarity of material characteristic. The hardness test informs that the result is about 42.5 HRA to 47.5 HRA. And the average result is about 44,83 that is relatively no changed by the exposure of weather. And furthermore evidence to confirm about the weather exposure impact is the micrographic structure of the materials. The microstructure of the materials are shown In the figure below :

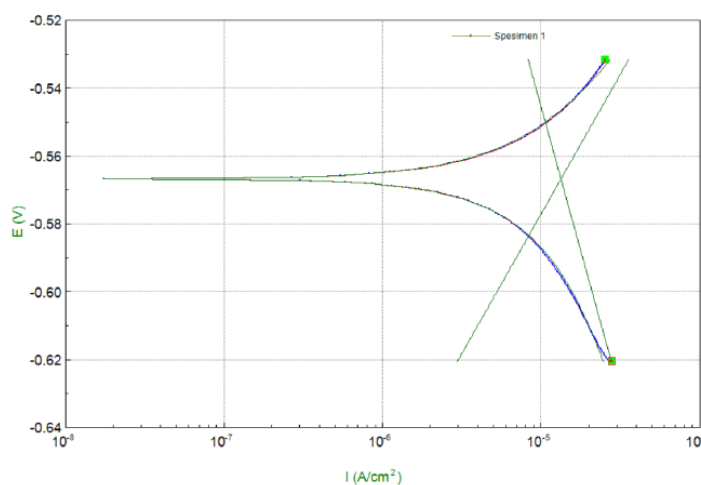
No	Parameter	Result
1	Potential	566.78 mV
2	Current	13.368 $\mu\text{A}/\text{cm}^2$
3	Corrosion rate	0.15525 mmpy

Figure 8. the result of corrosion rate.

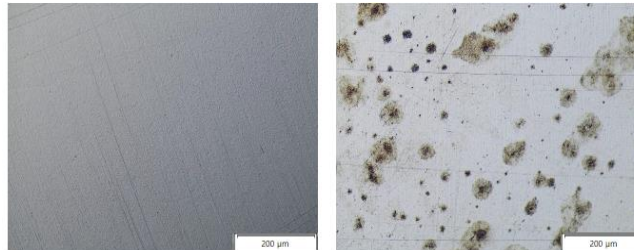
Figure 9. The microstructure magnification 50x, before corrosion rate testing on the left, and after corrosion rate testing on the right picture.
