## Locally Engineered Detachment System Rescuing Aneurysm Coiling when Regular Balt Coil Release Device Used to Detach Balt Coils Had a Technical Error

**ABSTRACT:** While performing posterior communicating aneurysm coiling, the framing of the aneurysm was performed but the coil detachment device was having an error which was only known when the coil was released into the aneurysm. The biomedical engineer within the operating room created a twelve voltage power supply circuit which was used to detach all the coils, thus rescuing the situation and saving the patient.

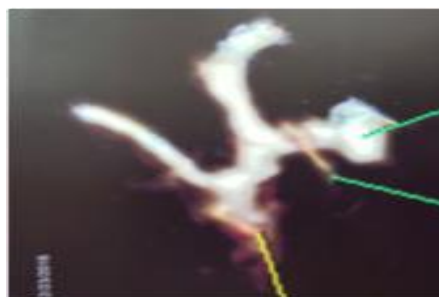
**Figure 1:** Pre-operative CT Angio showing aneurysm

CT Scan of the brain showed Subarachnoid Hemorrhage and the angiogram revealed a Left ICA Aneurysm at the communication segment measuring 6\*5 mm with a neck measuring 3mm. The patient was planned for an aneurysm coiling. The right femoral artery was accessed with a 5F femoral sheath and diagnostic angiography was performed and then changed to a 7F large sheath, whose tip

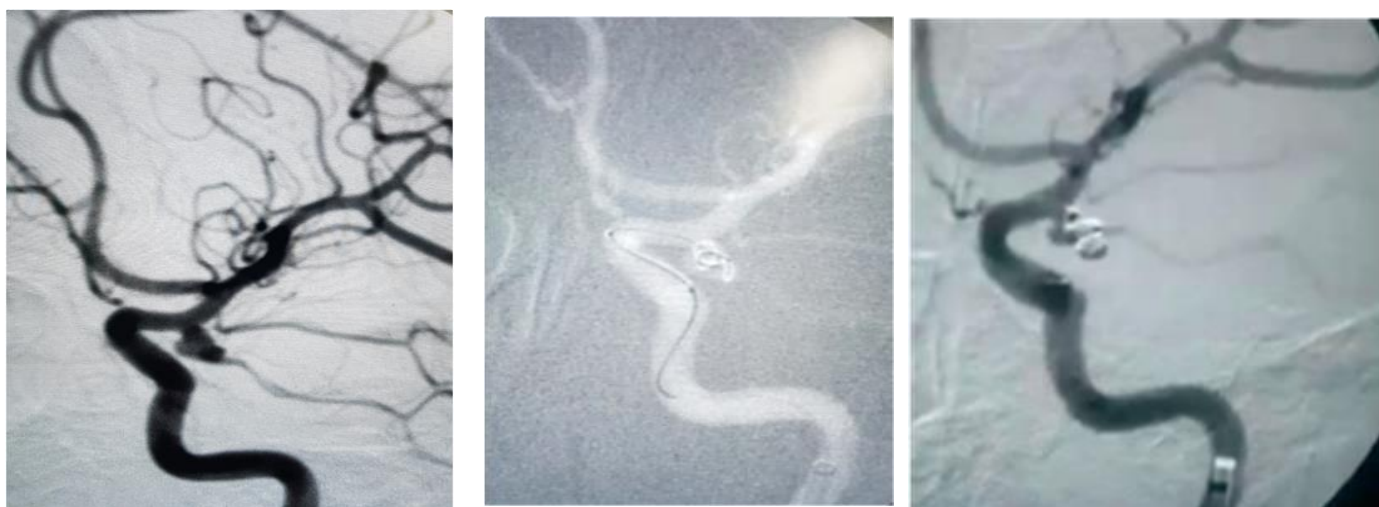
was placed in the left ICA with the help of a 0.035 Terumo guidewire and 5F vertebral diagnostic catheter. Fargomax was introduced to the left segment of the ICA. Vasco-microcatheter was introduced to the aneurysm with the help of a micro guidewire. 6 aneurysm coils were introduced using repeated fluoro and DSA protecting the PCOM Aneurysm coiling for the neck.

Figure 2: Intra-operative images showing the process of coiling.

After releasing the first coil into the aneurysm, we realized the detaching device was misplaced and was not present in time. The biomedical engineer thought of creating a 12 voltage power supply, which was then used to detach the coil. As the current was sent the ECG changes were noticed and detachment was confirmed. Barricade complex finish coils- 3mm x 8 6mm, 2.5mm\*4cm, 2mm\*4cm, 2mm\*2cm, 1.5mm\*2cm, 1.5mm\* 2cm. Altogether 6 coils were used.
